**THE GEOLOGICAL SITE AT TWO RIVERS PLATINUM MINE NEAR STEELPOORT, LIMPOPO PROVINCE**  
**STATE OF CONSERVATION REPORT**

Prepared By  
Edward Matenga (Ph.D.)

25 July 2024

**(AHSA) Archaeological and Heritage Services Africa (Pty) Ltd**

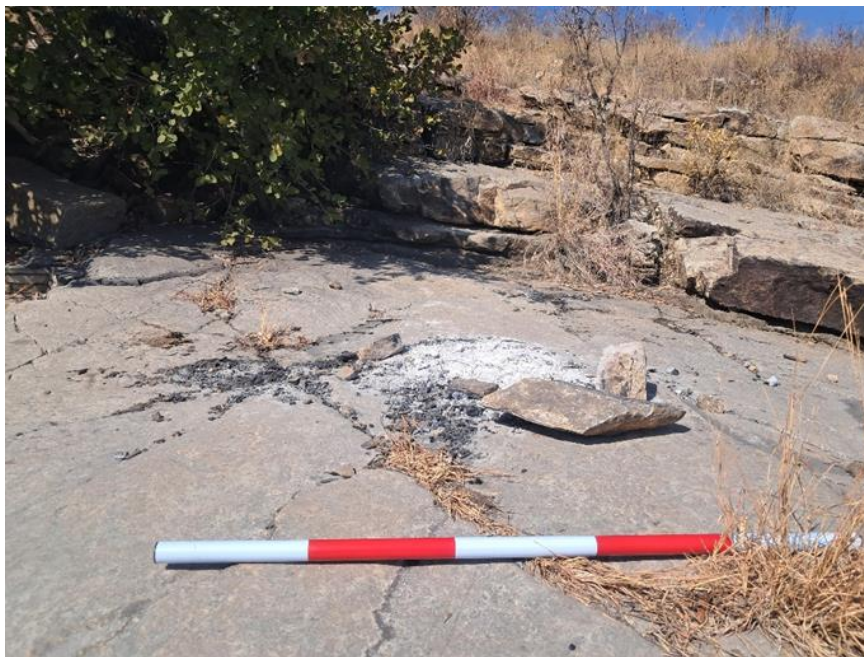
The pilgrims to the site leave behind litter – plastic paper and bottles, beverage bottles. The visitors make fires on the bedrock to warm themselves. Fire can cause the bedrock to crack, although no studies have been carried out yet to assess the impact of the fires. The granite information plaque at the site was broken into pieces in an apparent act of vandalism.

*Figure 12: A fire made on bedrock close to the east bank of the river.*

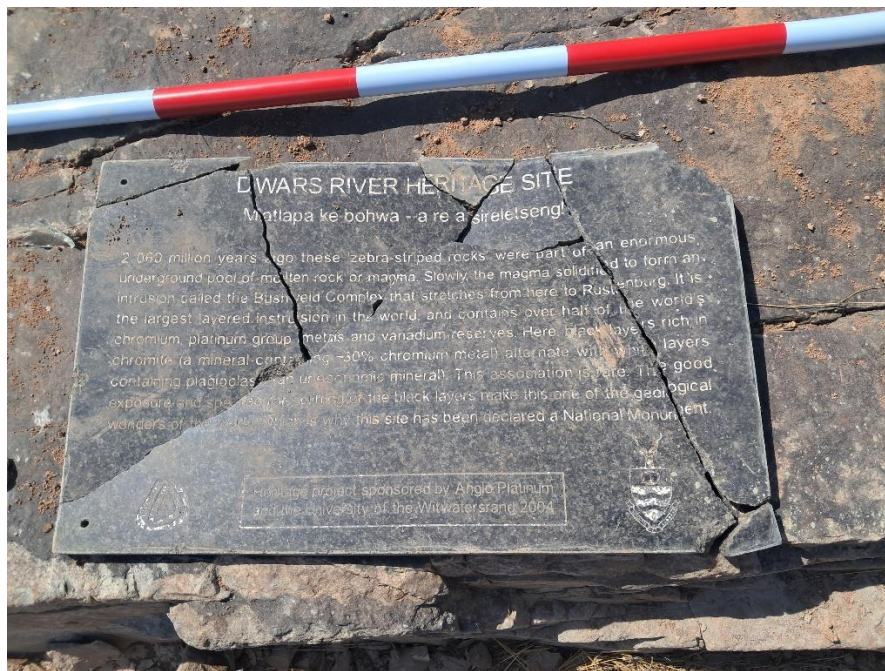
Figure 13: Granite information plaque that was vandalised.

The real and potential threats to the site must be addressed through the *Integrated Heritage Management Plan (IHMP)* which is being updated. Restoration of the information plaque must be considered in the light of ignorance about underlying reasons for the apparent malicious damage. The best route is to engage the community leaders for a common understanding on the treatment of the heritage site. In the interim, we propose that the information plaque is placed at the turn-off to the site from the road to the Two Rivers Platinum Mine North Decline (Lat: 24°54'42.24"S Long: 30° 6'12.46"E).

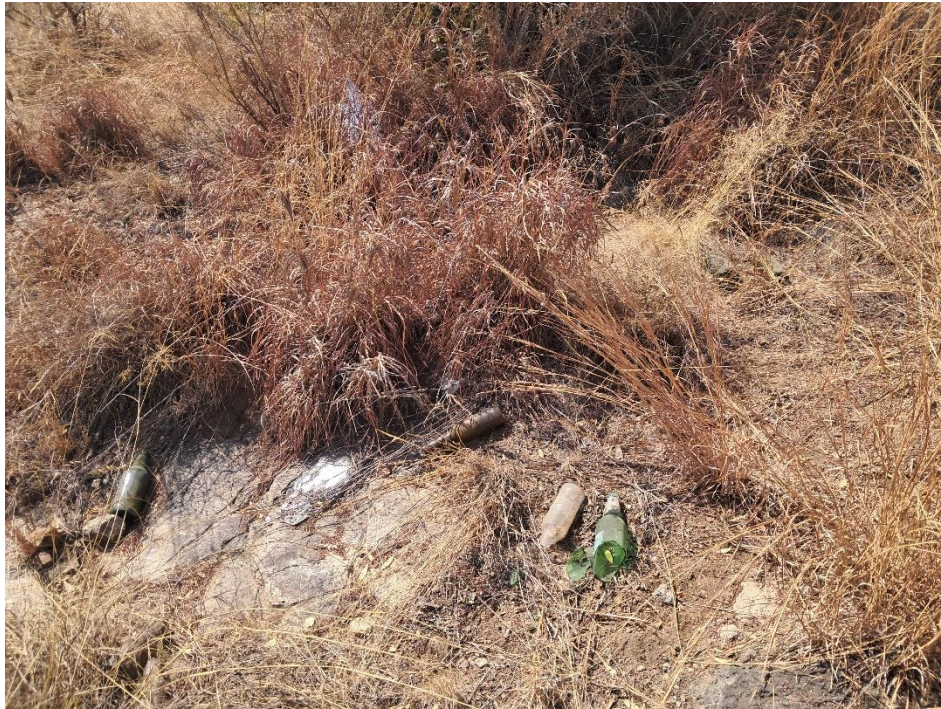
*Figure 15: Careless disposal of waste on the east bank of the river.*

The first thing is to provide facilities for responsible litter disposal, - waste bins. The Mine Waste Management programme must extend to the Heritage Site.

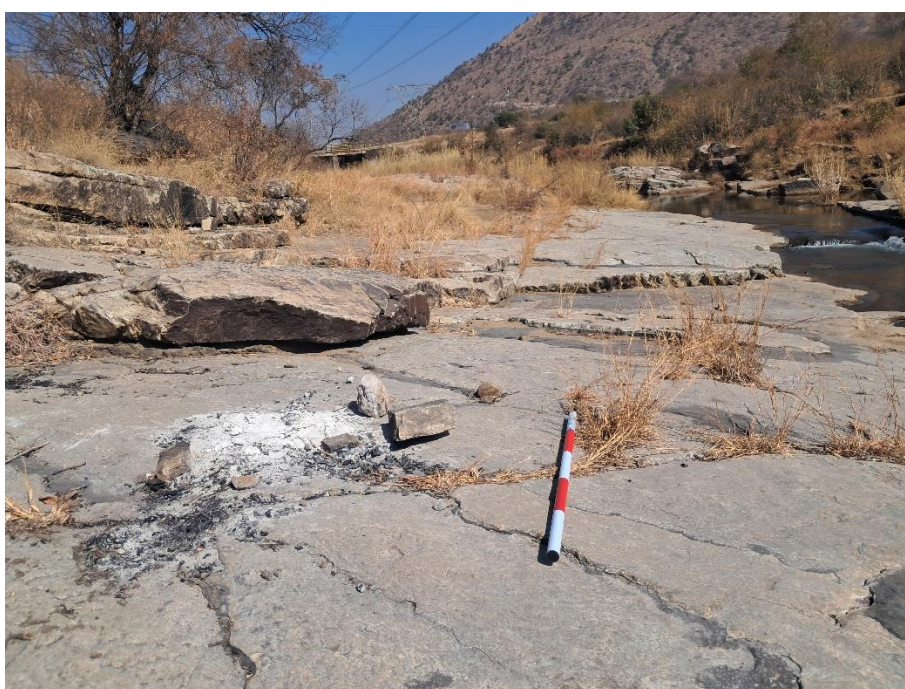
(d) Fires made on stream bedrock

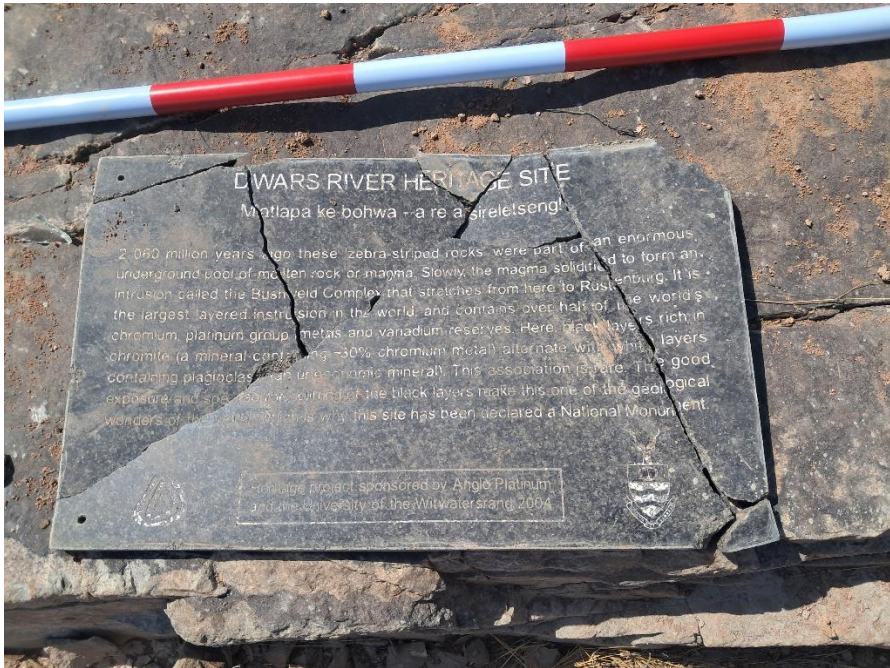
| COORDINATES | | |
|---|---|---|
| Fig 30 | Broken information Plaque | |

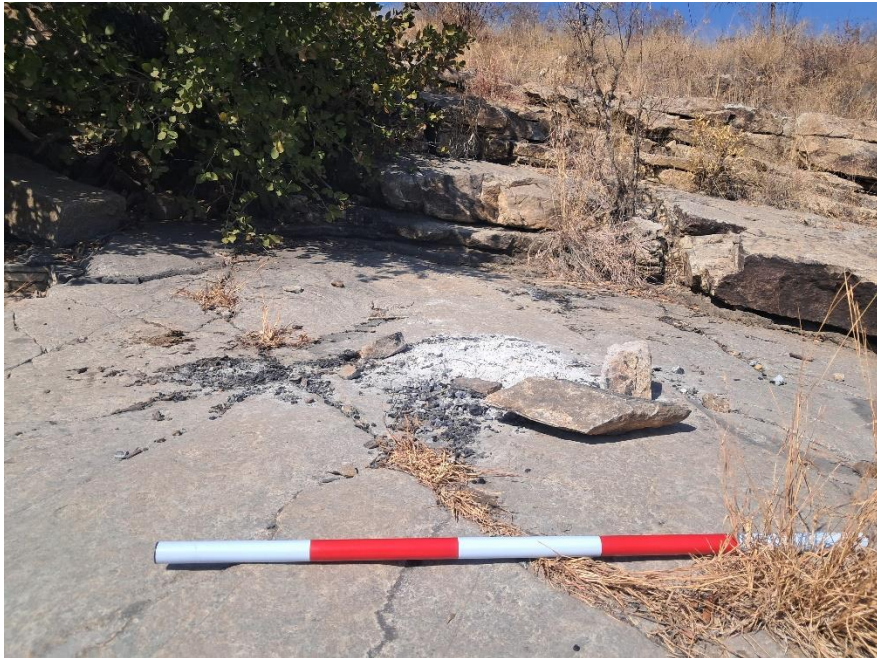
| COORDINATES | | |
|---|---|---|
| Fig 31 | A fire made on stream bedrock may cause it to crack | |

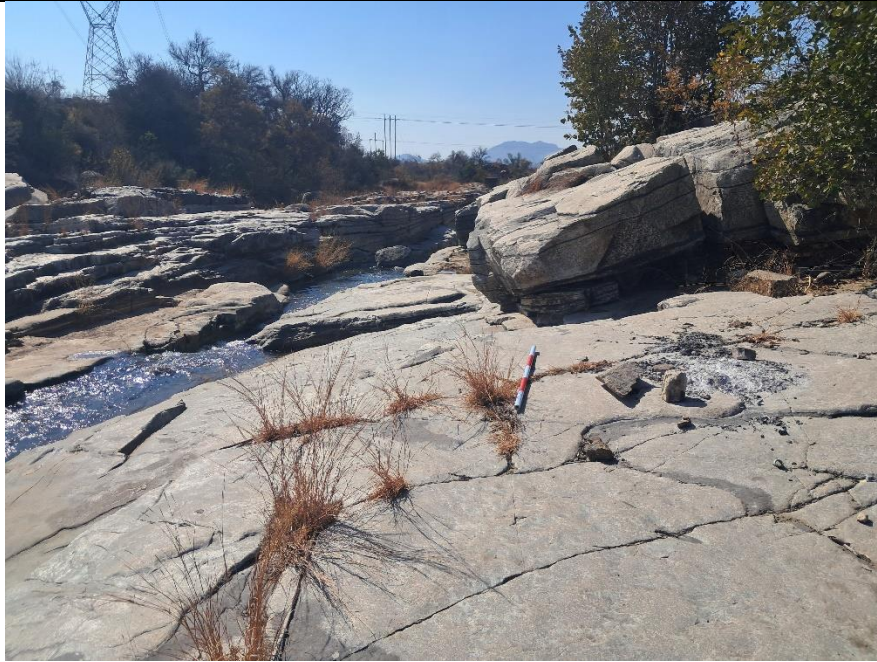
Fig 32 Another view of the fireplace showing its proximity to the river channel.

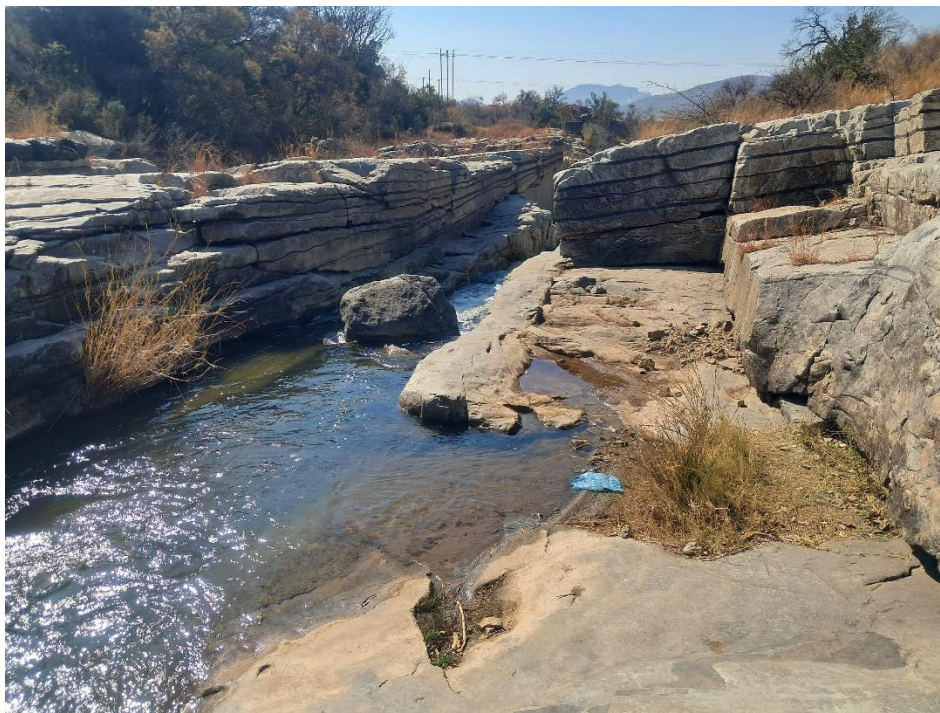
Fig 33 Plastic disposal.
