**THE GEOLOGICAL SITE AT TWO RIVERS PLATINUM MINE NEAR STEELPOORT, LIMPOPO PROVINCE**  
**STATE OF CONSERVATION REPORT**

Prepared By  
Edward Matenga (Ph.D.)

25 July 2024

**(AHSA) Archaeological and Heritage Services Africa (Pty) Ltd**

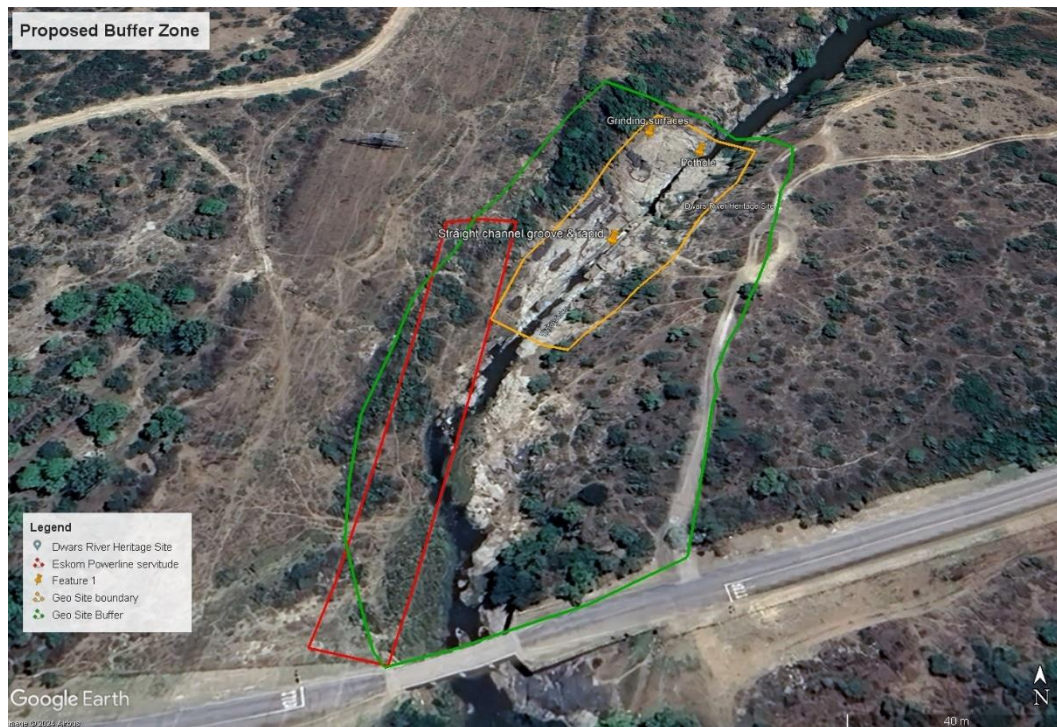
Figure 11: Proposed buffer zone boundary. Note that on the west bank the proposed boundary encroaches on the Eskom 400kV powerline servitude outlined in red.

Since the proposed boundary of the core of the property is along the stream banks it is difficult to erect a fence, even without considering likely negative visual impact of such fencing. A perimeter fence can be erected along buffer zone boundary, mindful that the proposed boundary encroaches into 400kV powerline servitude on the west side of the stream.

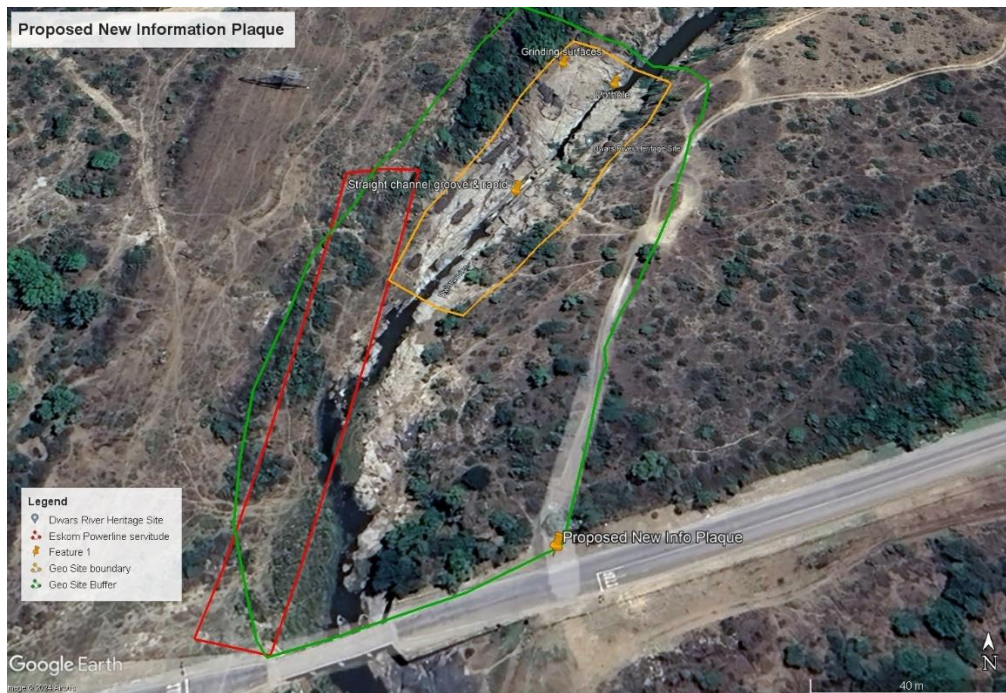
Figure 14: Proposed location of a new information plaque.

The real and potential threats to the site must be addressed through the *Integrated Heritage Management Plan (IHMP)* which is being updated. Restoration of the information plaque must be considered in the light of ignorance about underlying reasons for the apparent malicious damage. The best route is to engage the community leaders for a common understanding on the treatment of the heritage site. In the interim, we propose that the information plaque is placed at the turn-off to the site from the road to the Two Rivers Platinum Mine North Decline (Lat: 24°54'42.24"S Long: 30° 6'12.46"E).

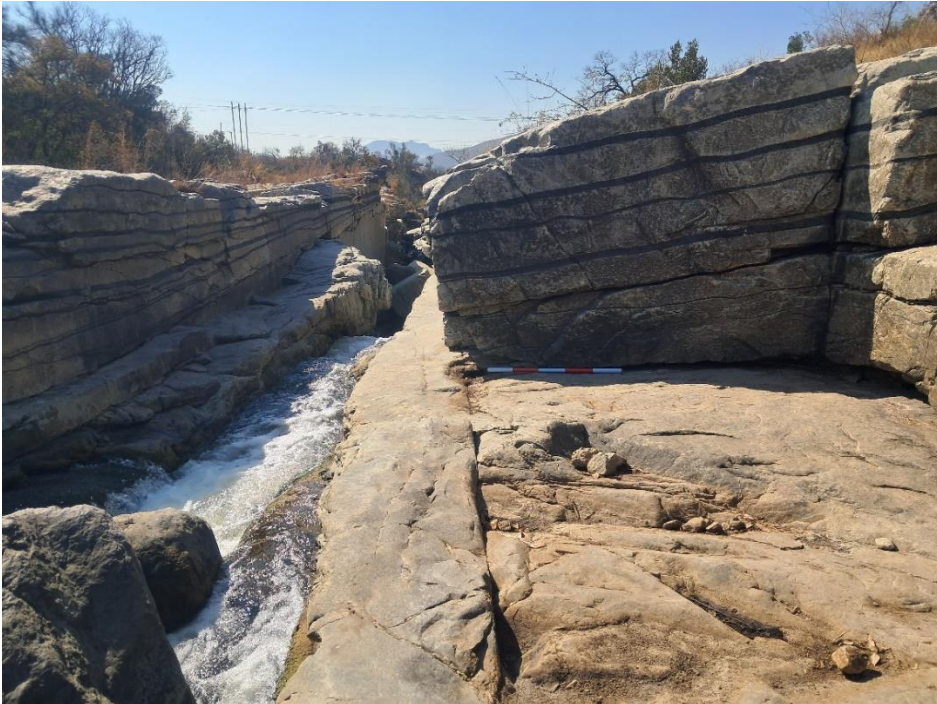
| COORDINATES | | |
|---|---|---|
| | (a) Coins deposited on the foot of the rock close to the channel (right end of pole). | |

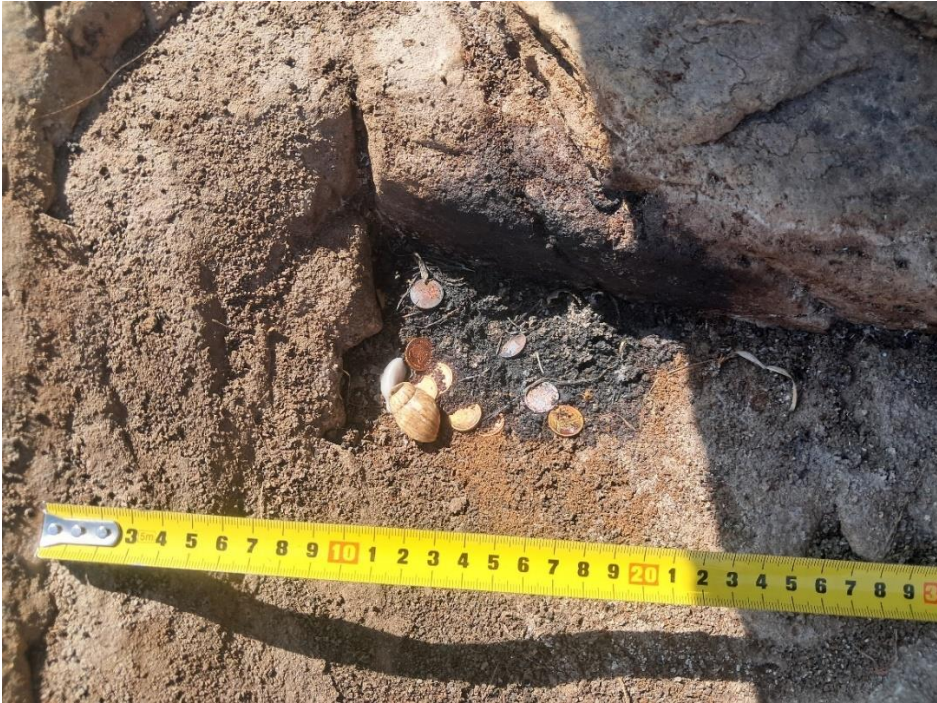
| COORDINATES | | |
|---|---|---|
| | (b) Close view of sacrificial coins and snail shell. | |

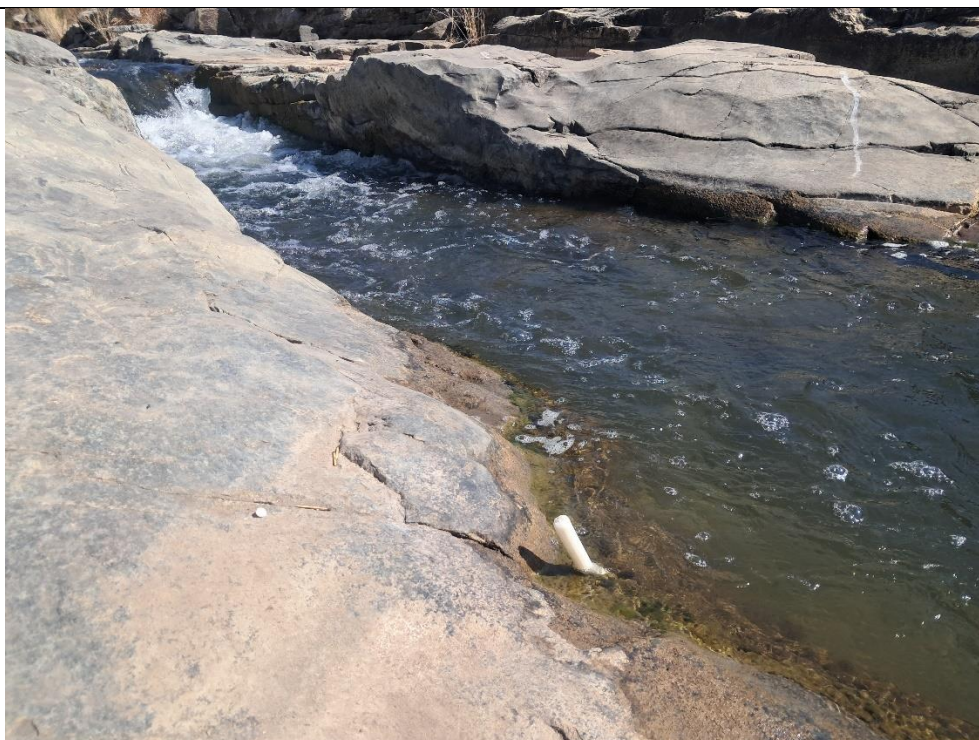
(c) Candle stick used during a night vigil.
